CASE STUDY –
DEFECTS SURVEY
GRADE II LISTED HOUSE, DANBURY, ESSEX

JANICE GOOCH
JANICE GOOCH HERITAGE CONSULTANCY
Case Study 009

Case Study for:
Grade II Listed House, Danbury, Essex

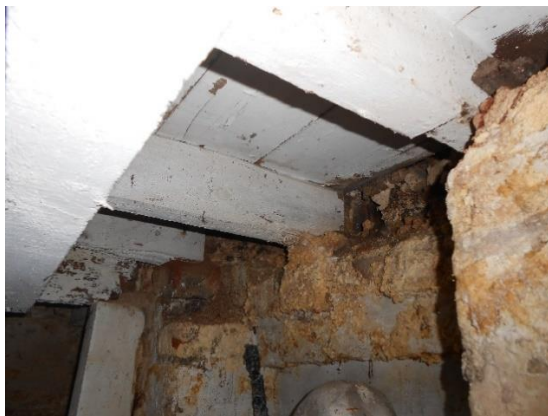
Figure 2 - Cellar of building dated c1650, embedded timber joists within brick wall

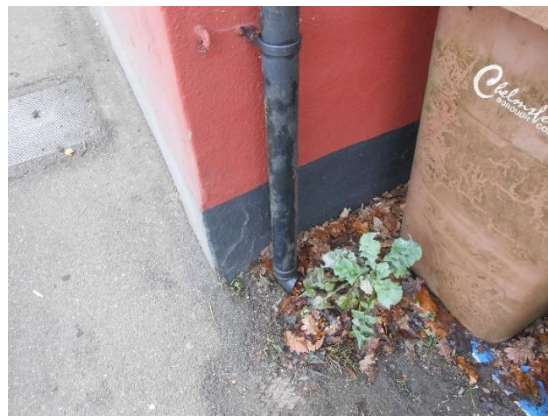
Figure 3 - Exterior with build-up of debris and downpipe discharging towards building

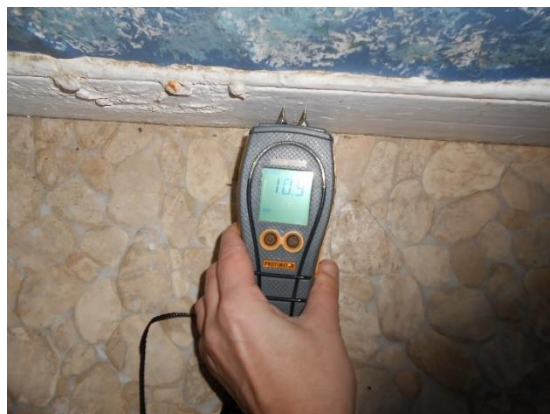
Figure 4 - Damp meter providing indication of defects
